Lake Pupuke Inspection Report No. KC71

1 INTRODUCTION

1.1 Purpose of Document

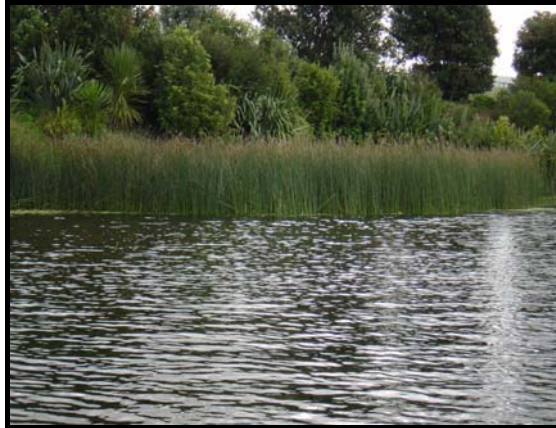
Eco-point: 1006-1007

Area in ha: 0.01

Description: Hollow stemmed reeds

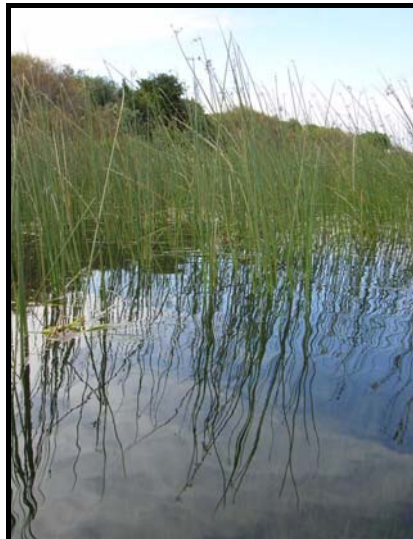
Eco-point: 1010-1011

Area in ha: 0.08

Description: Emergent hollow stemmed reeds, flax

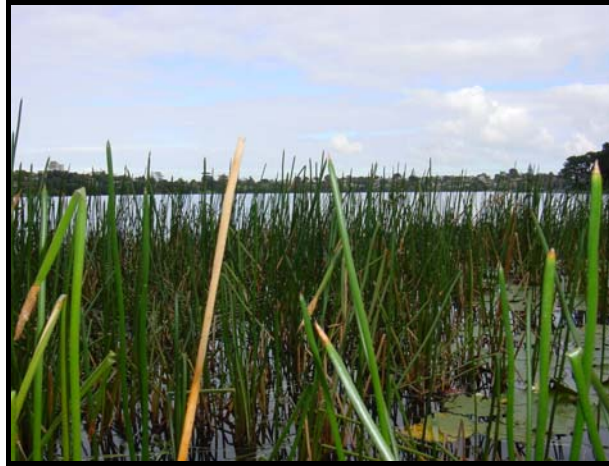
Eco-point: 1012-1013

Area in ha: 0.04

Description: Hollow stemmed reeds, flax

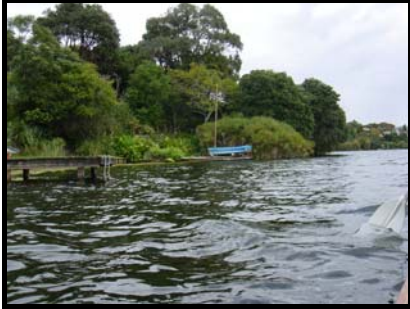
1001 – 1002	<p>Length: 70m Modifications: 80% reinforcing Bank height: 0.8m Bank angle: 35° Erosion: 10% Vegetation: No canopy or sub canopy, just cut grass Lakeside vegetation cover: 0%</p>

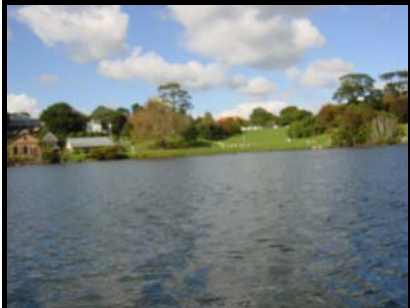
1002 – 1003	<p>Length: 78m Modifications: 80% reinforcing Bank height: 0.8m Bank angle: 35° Erosion: 20% Vegetation: No canopy or sub canopy, just cut grass Lakeside vegetation cover: 5%</p>
1003 – 1004	<p>Length: 167m Modifications: No modification, basalt rock Bank height: 0.8m Bank angle: 60° Erosion: 10% Vegetation: Native throughout reach Lakeside vegetation cover: 10%</p>

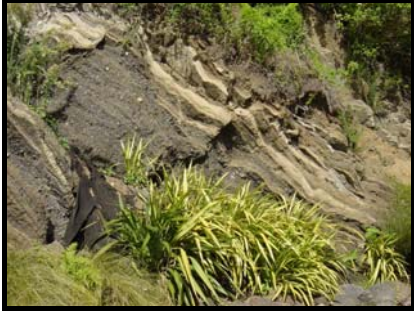
1004 – 1005	<p>Length: 190m Modifications: 80% reinforcing, wood Bank height: 0.8m Bank angle: 60° Erosion: 0% Vegetation: Mixed throughout Lakeside vegetation cover: 10%</p>

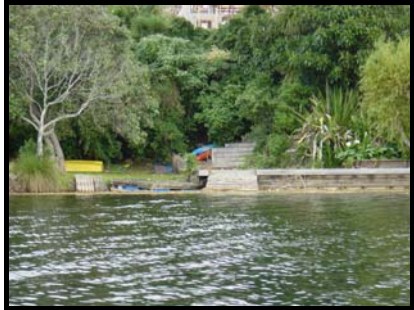
1005 – 1006	<p>Length: 360m Modifications: 80% rock wall lining Bank height: 0.8m Bank angle: 80° Erosion: 0% Vegetation: Mixed throughout Lakeside vegetation cover: 10%</p>

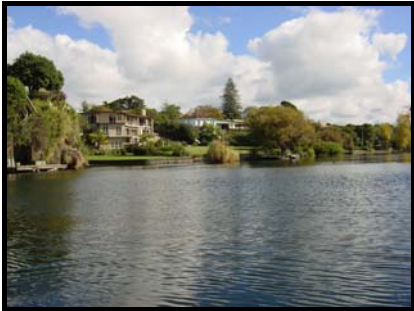
Reach No.	Summary of Physical Details
1006 – 1007	<p>Length: 490m Modifications: 70% lined Bank height: 0.8m Bank angle: 70° Erosion: 0% Vegetation: Mixed to exotic throughout Lakeside vegetation cover: 5%</p>

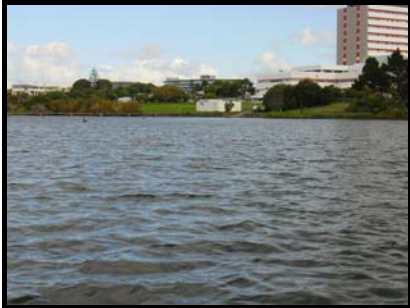
1007 – 1008	<p>Length: 310m Modifications: 60% lined 40% unlined Bank height: 0.6m Bank angle: 40° Erosion: 5% Vegetation: Exotic throughout Lakeside vegetation cover: 10%</p>

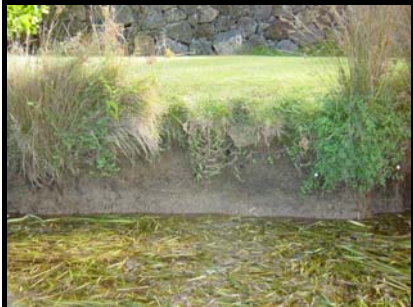
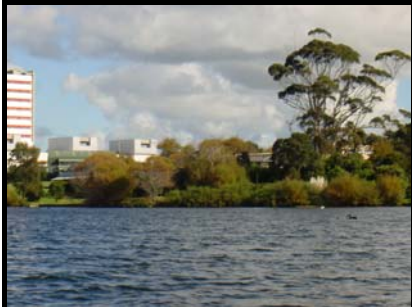
1008 – 1009	<p>Length: 227m Modifications: Unlined Bank height: 0.3m Bank angle: 40° Erosion: 10% Vegetation: Exotic throughout Lakeside vegetation cover: 60%</p>

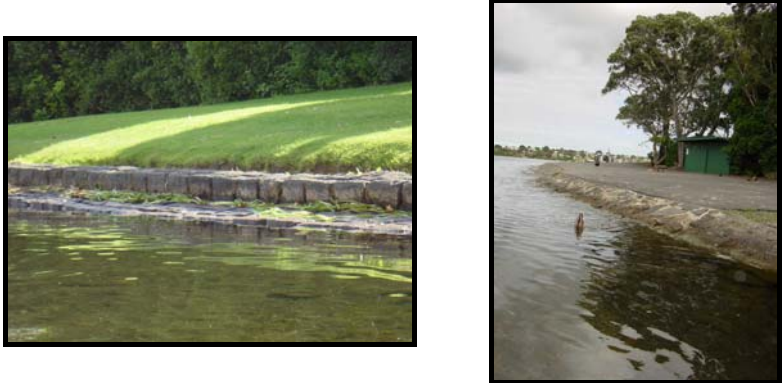
1012 – 1013	<p>Length: 370m Modifications: 10% lined banks (wood) Bank height: 0.3m Bank angle: 10° Erosion: 10% Vegetation: Mixed throughout Lakeside vegetation cover: 20%</p>

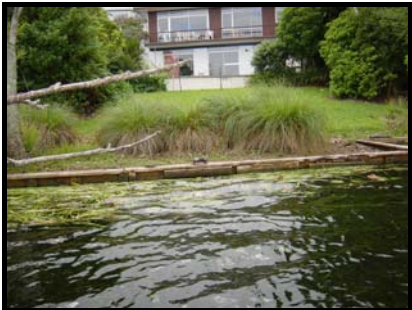
1013 – 1014	<p>Length: 135m Modifications: 100% lined rock wall Bank height: 0.3m Bank angle: 35° Erosion: 0% Vegetation: No canopy mixed sub canopy and ground cover Lakeside vegetation cover: 20%</p>

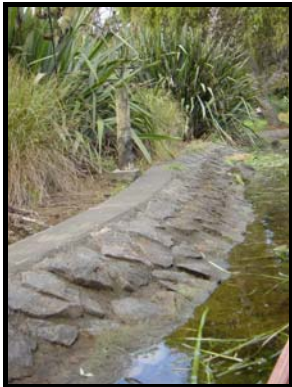
1014 – 1015	<p>Length: 100m Modifications: 100% lined banks Bank height: 0.8m Bank angle: 90° Erosion: 0% Vegetation: No canopy mixed sub canopy and ground cover Lakeside vegetation cover: 0%</p>
1015 – 1016	<p>Length: 565m Modifications: 10% reinforced banks Bank height: 0.3m Bank angle: 40° Erosion: 10% Vegetation: Native canopy mixed sub canopy and ground cover Lakeside vegetation cover: 30%</p>

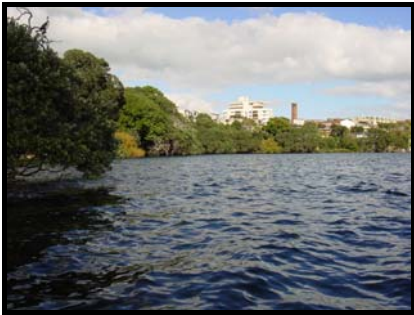
1016 – 1017	<p>Length: 144m Modifications: 30% reach reinforced banks Bank height: 0.4m Bank angle: 30° Erosion: 15%</p>

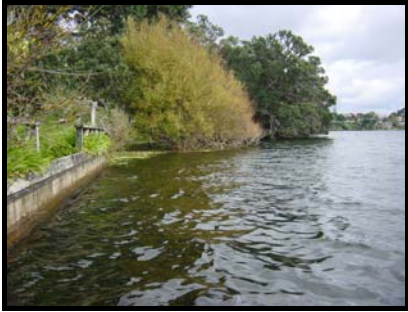
Reach No.	Summary of Physical Details
	<p>Vegetation: Native canopy mixed sub canopy and ground cover Lakeside vegetation cover: 35%</p>

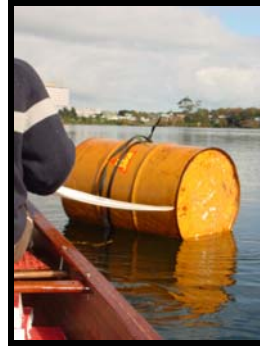
The majority of inorganic debris observed during the lake survey consisted of plastic bags and general street litter, which enter through stormwater pipes (see left hand photo below). A 40-gallon drum was also observed and removed (see right hand photo below). Overall, insignificant amounts of inorganic debris were observed.

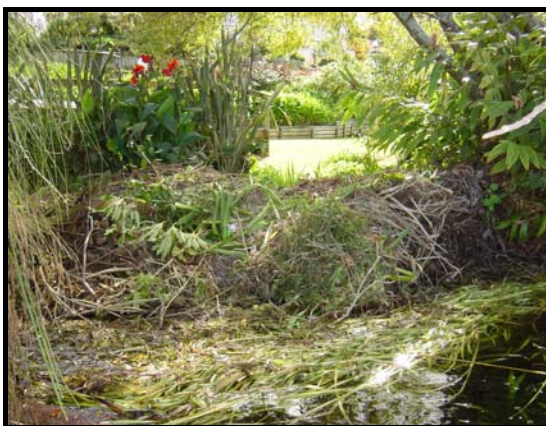
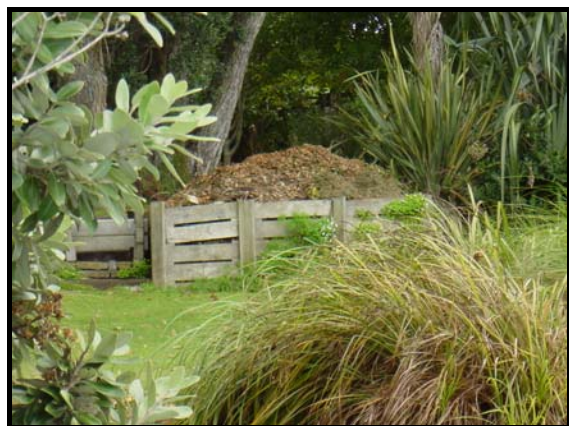
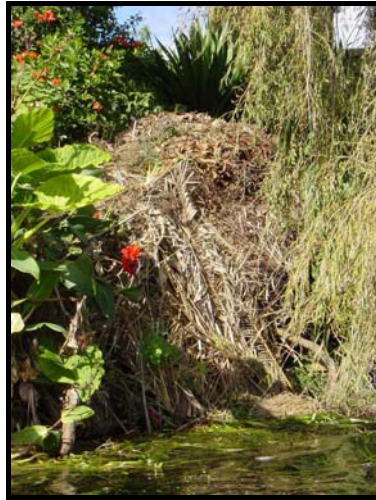
As part of the lake edge survey any organic material “dumps” (including compost heaps) were noted and photographed, as these are potential sources of nutrients and organic matter to the lake.

Below are photos of several “dumps” or compost heaps observed near the lake edge during the survey.
